Re: October 2016 Monthly Progress Report
Administrative Settlement Agreement and Order on Consent for Removal Action
U.S. EPA Region 10 Docket No. CERCLA 10-2009-0255
Gasco Sediments Site within the Portland Harbor Superfund Site

Attachment A Monthly Visual Monitoring Report for Pilot Cap Vicinity

Visual Observations Log Form

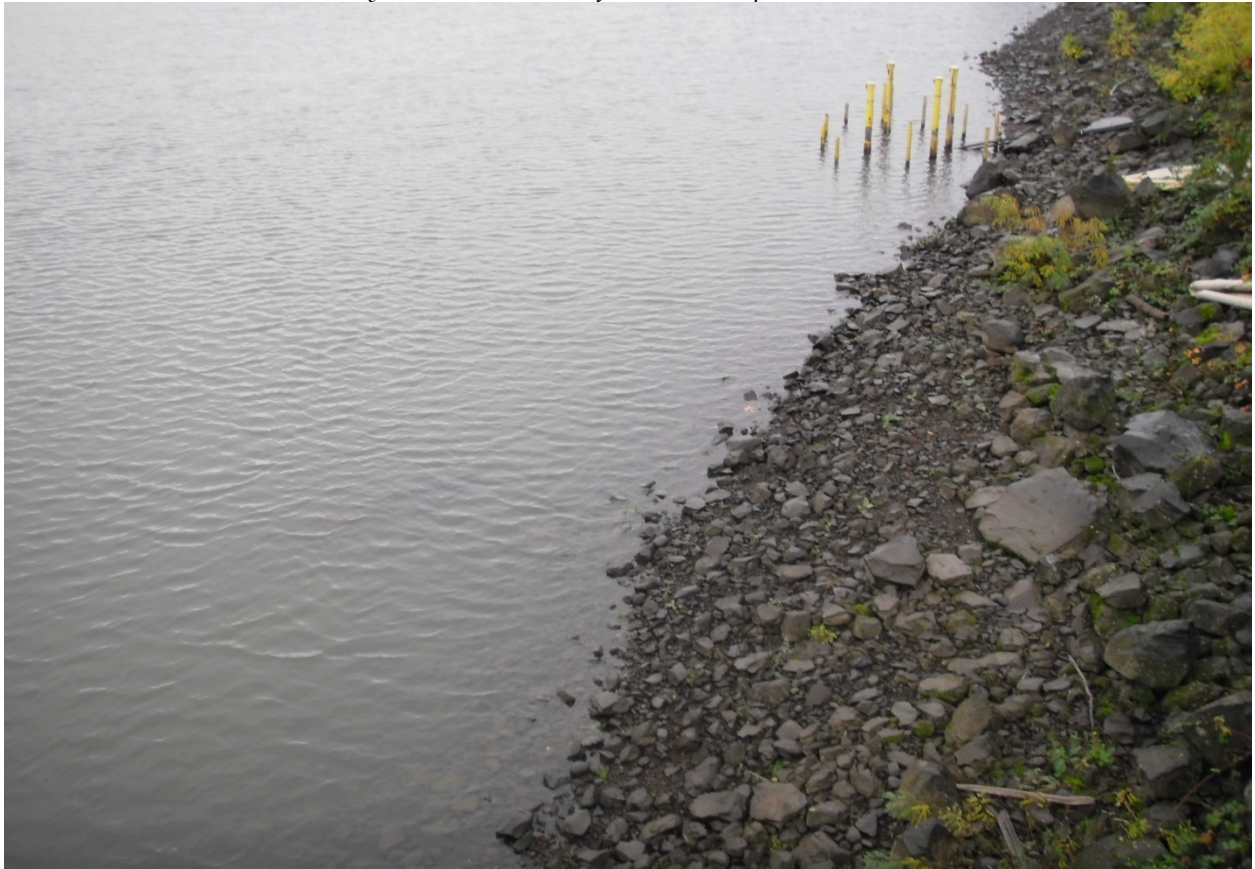
Observations of Erosion/Deposition: No erosion/deposition is evident along the shoreline. The shoreward extent of the cap was not visible due to river water level elevation. The extents of the organo-clay mat material were also submerged. (Photo 1).

Photo 1 — *River level currently above the extent of sediment cap (10/24/16):*

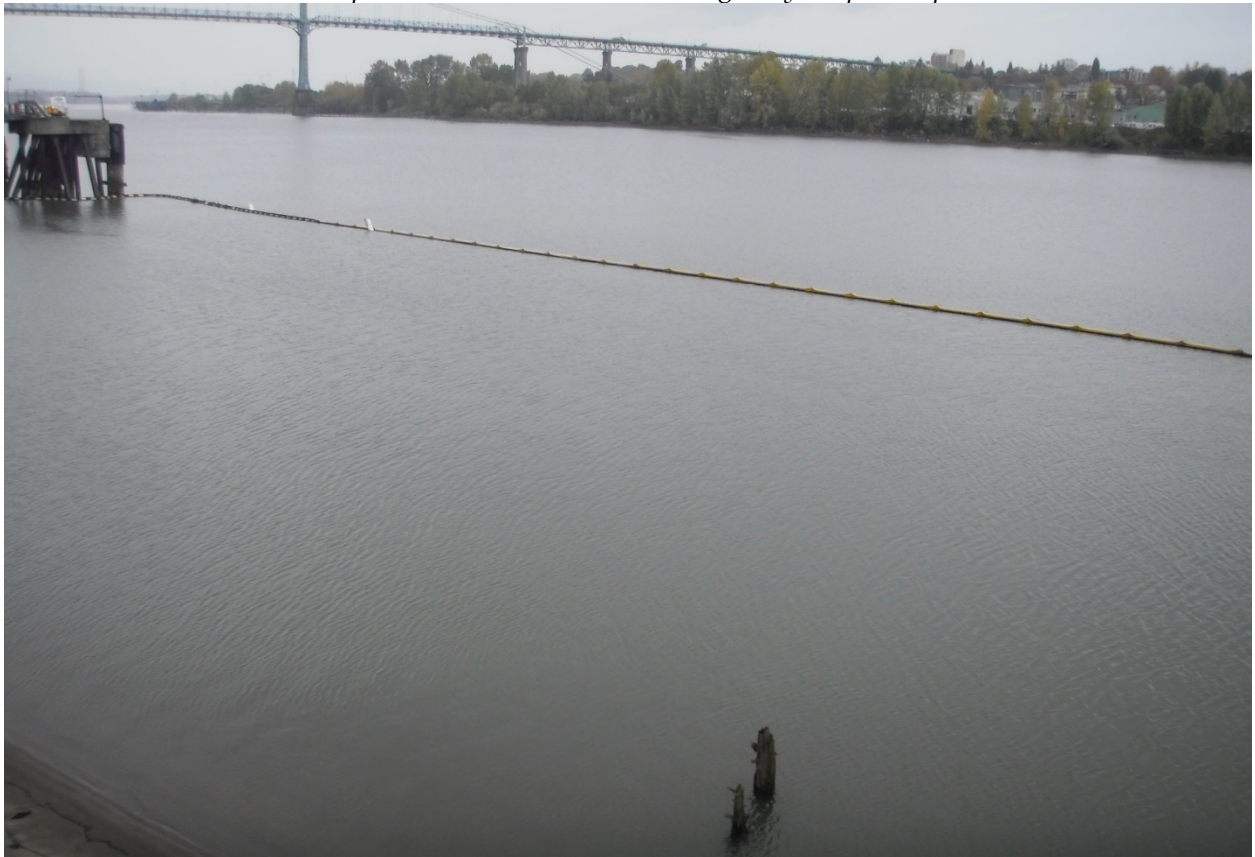
Observations of Long-term Controls (i.e., oil booms, organo-clay mat, etc.) During the observation, the FAMM containment boom was placed across the cap area from the ship dock to an anchor point riverward of the upriver dolphin. Two buoys that identify the cap area to mariners were in place as installed. The position of the FAMM oil boom and warning buoys is shown in Photo 2.

Photo 2 — *FAMM oil boom placement and mariner warning buoys at pilot cap area. (10/24/16):*

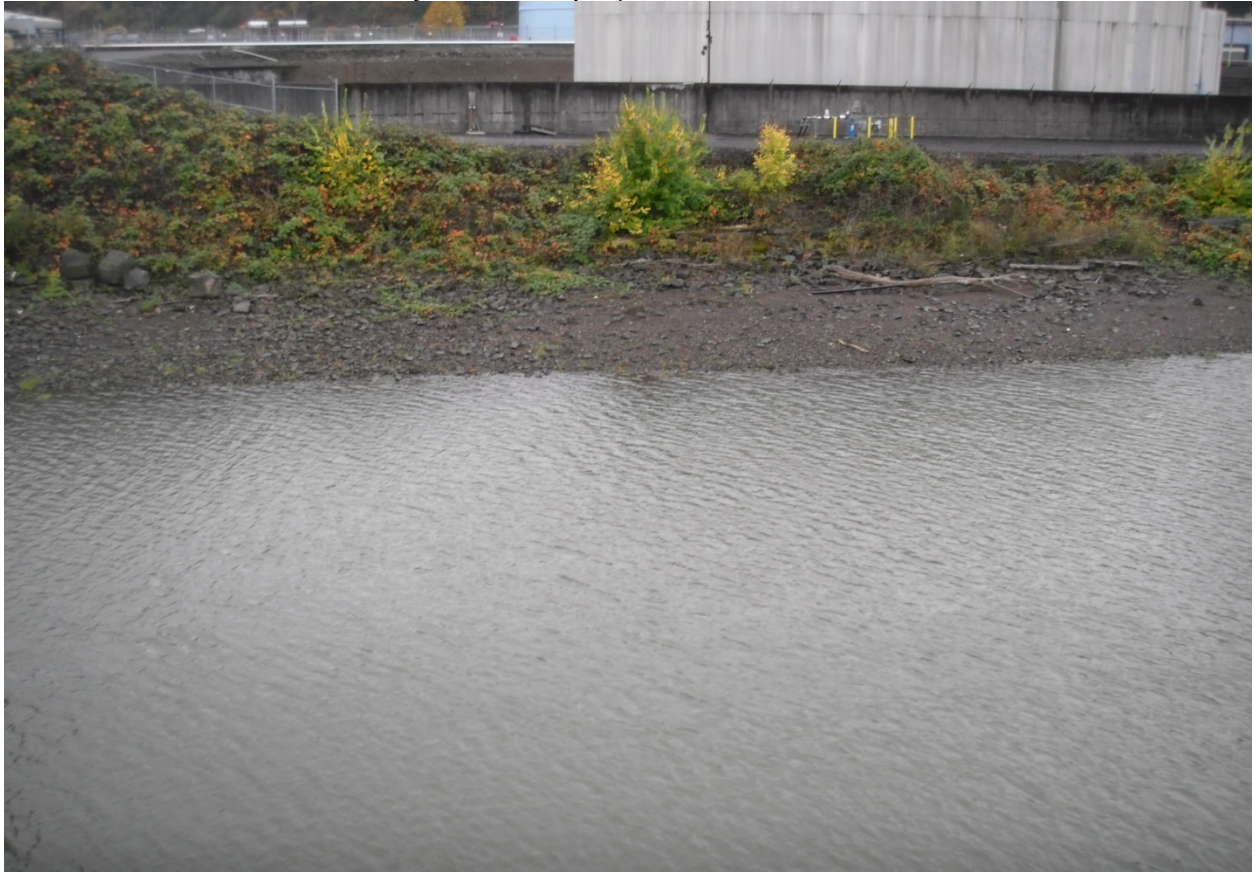
Other Comments: No sheen was evident in or around the cap area. Photo 3 shows the water surface and shoreline immediately downriver of the sediment cap.

Photo 3 — *Conditions immediately downriver of cap area (10/24/16):*
